Surface Cracking and Interface Reaction Associated Delamination Failure of Thermal and Environmental Barrier Coatings

1. AGENCY USE ONLY (Leave blank)	2. REPORT DATE April 2003	3. REPORT TYPE AND DATES COVERED Technical Memorandum		
4. TITLE AND SUBTITLE Surface Cracking and Interface Reaction Associated Delamination Failure of Thermal and Environmental Barrier Coatings		5. FUNDING NUMBERS WBS-22-714-04-05 1L161102AF20

9. SPONSORING/MONITORING AGENCY NAME(S) AND ADDRESS(ES) National Aeronautics and Space Administration Washington, DC 20546-0001 and U.S. Army Research Laboratory Adelphi, Maryland 20783-1145		10. SPONSORING/MONITORING AGENCY REPORT NUMBER NASA TM-2003-212318 ARL-TR-2969

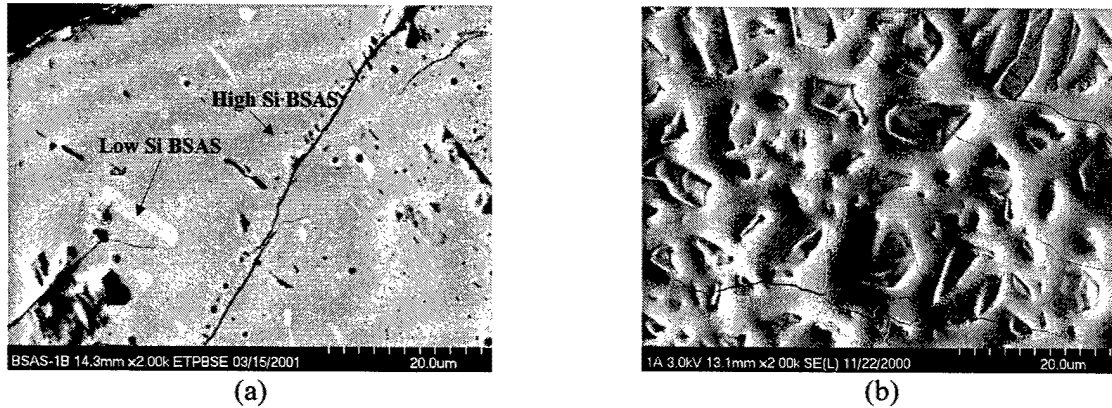
Figure 1.—(a) The BSAS coating was decomposed into low Si (bright second phase) and high Si (dark matrix) phases during initial laser thermal cyclic testing. (b) The higher Si phase became the glass phase and surface cracks were formed after 100 hour cyclic testing at the surface temperature of 1482 °C.

Figure 1 shows SEM microstructures of the BSAS/Si environmental barrier coating after laser thermal gradient cyclic testing. It can be seen from Figure 1 (a) that the BSAS coating was first decomposed and precipitated a lower silicon (Si) containing phase, with the matrix being a high Si containing BSAS. As the coating was further cyclically tested at a surface temperature of 1482 °C, the BSAS matrix was melted because of the formation of the higher Si and lower melting point BSAS. The surface cracking was also observed after coating melting and glass phase formation.

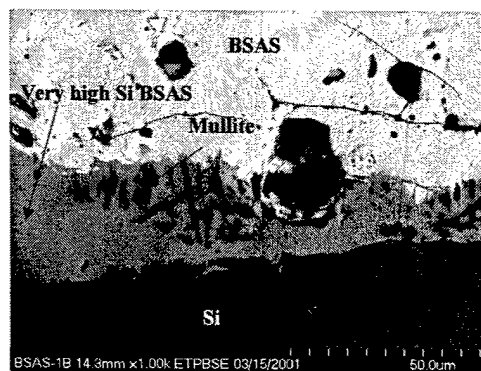
Figure 2.—SEM cross-section micrograph of the BSAS coating after 100 hour laser thermal gradient cycling test. The interface reactions resulted in a dark reaction BSAS layer with high Si concentrations. The mullite phase (very dark needle-shaped phase) precipitation was also found within the high Si reaction BSAS region.

Figure 2 shows a SEM cross-section micrograph of the BSAS coating after 100 hour laser thermal gradient cycling test. The interface reactions between the Si bond coat and BSAS coating resulted in a dark reaction layer with the layer thickness of 30 to 40 microns. The EDS analysis has shown that this BSAS region has very high Si concentrations due to the Si diffusion from the Si bond coat into the BSAS. The high Si concentration BSAS phase was also decomposed into mullite phase (very dark needle-shaped phase) within the high Si BSAS reaction region. Although the coating interface melting was not observed under the 1300 °C interface temperature of the thermal gradient testing for 100 hours, the high Si concentration BSAS reaction layer has been reported to facilitate the coating melting and the glass phase formation under the uniform temperature furnace testing in a water vapor environment at higher temperatures (ref. 5).

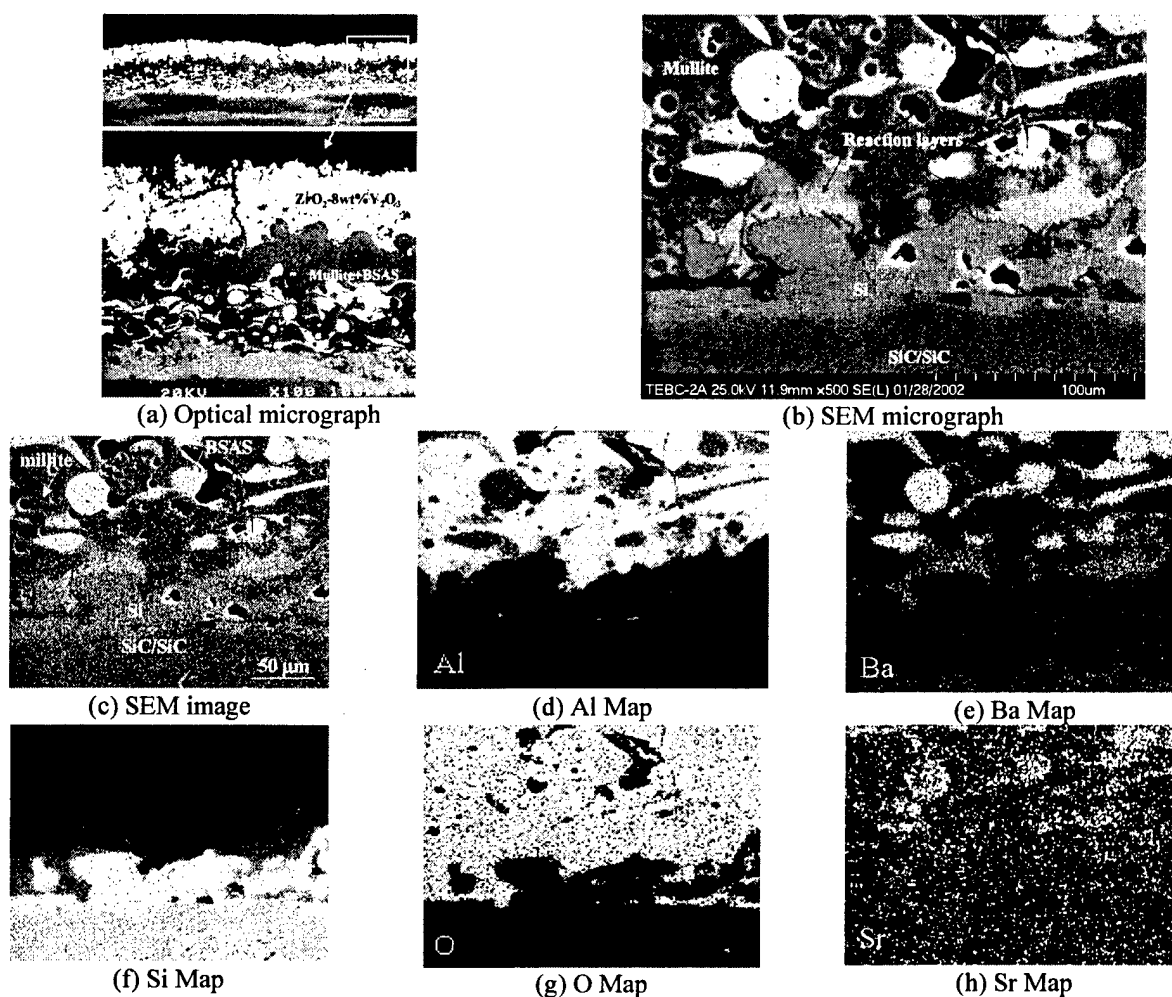
Figure 3.—SEM images and EDS element composition maps of the $ZrO_2-8wt\%Y_2O_3/BSAS+mullite$ mixture/Si on SiC/SiC ceramic matrix composite substrates after laser testing, showing significant interface reactions between BSAS and bond coat Si layer, and the BSAS and mullite. (a) and (b) Optical and SEM micrographs of the coating after 100 hours testing, showing the surface cracking and interface reactions; and (c) to (h) SEM cross-section micrograph and the corresponding EDS elemental maps for the coating systems near the interface.

Figure 3 shows cross-section micrographs and compositional maps of the ZrO_2 -8wt% Y_2O_3 /BSAS+mullite mixture/Si on a SiC/SiC ceramic matrix composite substrate, after 100 hours testing in a combined alternating laser thermal gradient cyclic and furnace water vapor exposure cyclic

testing. It can be seen that substantial thermal gradient induced coating surface wedge-shape cracking has occurred and the resulting delamination was observed for the coating specimen. As shown in Figure 3, significant interface reactions within the mullite+BSAS EBC layer occurred. The reaction affected zone can be as thick as 30 to 40 microns, especially near the interface and the BSAS phase (bright phase) regions. The reactions between mullite and BSAS phases were also noticed with a typical reaction layer thickness of 2 to 5 microns. However, the inter-diffusion of Ba and Al between the mullite and BSAS can occur at a much greater distance, as indicated by the EDS composition maps in Figure 3 (d) and (e). The reactions were further enhanced by the surface crack penetrations into the EBC layer which allowed the water vapor fast access to the coating at the EBC/Si interface. The accelerated coating damage under the thermal gradient cyclic testing combined with the furnace water vapor testing was attributed to the increased delamination driving force under the thermal gradient cyclic loading and the reduced interface adhesion due to the detrimental interface reactions (refs. 4, 6).

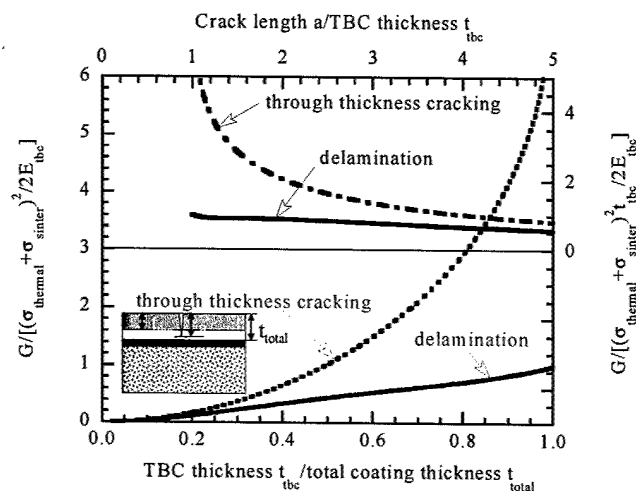
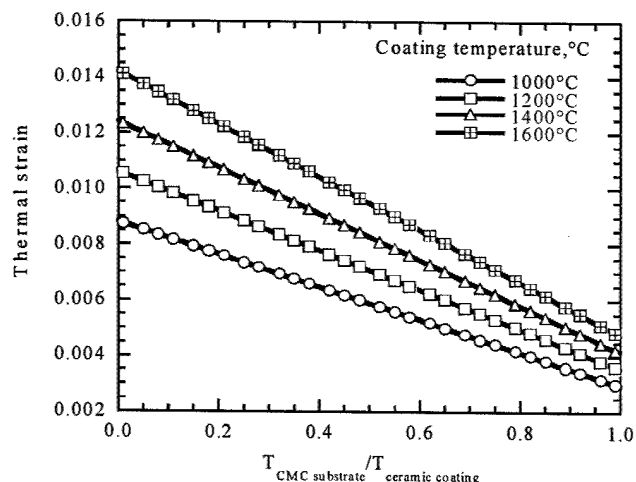
Figure 4.—(a) $\text{ZrO}_2\text{-Y}_2\text{O}_3$ TBC layer on mullite-BSAS EBC and CMC substrates, the coating surface cracking and delamination energy release rates can increase significantly with a relatively thick, and larger thermal expansion $\text{ZrO}_2\text{-Y}_2\text{O}_3$ TBC layer on mullite-BSAS EBC on CMC substrates. (b) The significantly larger thermal stresses/strains will be generated with increasing the thermal gradients (the temperature difference between the ceramic coating and the substrates).

The coating surface cracking is largely due to ceramic top coat sintering and thermal expansion mismatch, especially under the large thermal gradient conditions. As can be seen in Figure 4, with a relatively thick, higher thermal expansion $\text{ZrO}_2\text{-Y}_2\text{O}_3$ TBC layer on mullite-BSAS EBC and CMC substrates, the coating surface cracking and delamination driving force can increase significantly, based on a thermal gradient testing delamination model proposed in the literature (ref. 7). The significantly larger thermal stresses generated under thermal gradients will also accelerate the coating delamination under the thermal cyclic conditions.

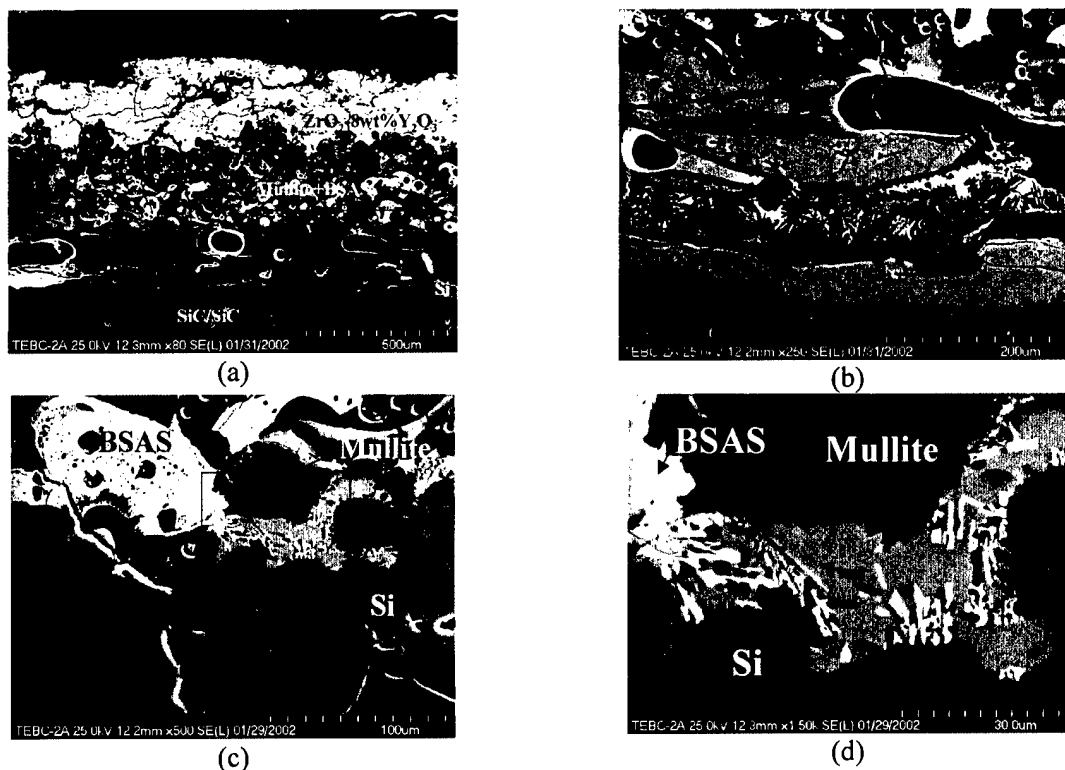
Figure 5.—SEM cross-section micrographs of the $\text{ZrO}_2\text{--}8\text{wt}\%\text{Y}_2\text{O}_3/\text{BSAS+mullite mixture/Si}$ on a SiC/SiC ceramic matrix composite substrate, after total 400 hours testing in the combined laser thermal gradient and furnace water vapor cyclic testing. (a) Significant interfacial pore formation due to the water vapor attack through the vertical cracks under the thermal gradient cycling conditions. (b) Low melting eutectic phase was also observed near the BSAS-mullite-Si interfaces after the testing.

Figure 5 shows the SEM cross-section micrographs of the $\text{ZrO}_2\text{--}8\text{wt}\%\text{Y}_2\text{O}_3/\text{BSAS+mullite mixture/Si}$ on a SiC/SiC ceramic matrix composite substrate, after 400 hours of testing in the combined laser thermal gradient and furnace water vapor cyclic testing. Extensive coating delamination and some spallation were observed during the testing. From Figure 5 (a) and (b), it can be seen that, in addition to the more significant reactions between the EBC mullite, BSAS and Si bond coat, large interfacial pores developed due to the water vapor attack through the vertical cracks in the EBC coatings. From Figure 5 (c) and (d), it can also be seen that a low melting point eutectic phase around the BSAS, Si, and mullite interfaces formed. For the top $\text{ZrO}_2\text{--Y}_2\text{O}_3$ coating side, no obvious reactions were found between mullite and $\text{ZrO}_2\text{--}8\text{wt}\%\text{Y}_2\text{O}_3$ coatings after the 400 hours combined laser and furnace water vapor thermal cycling test.
